# **Navajo Abandoned Uranium Mine**

## **Site Screen Report**

### **Carl Yazzie 1 AUM Site**

**March 2010**

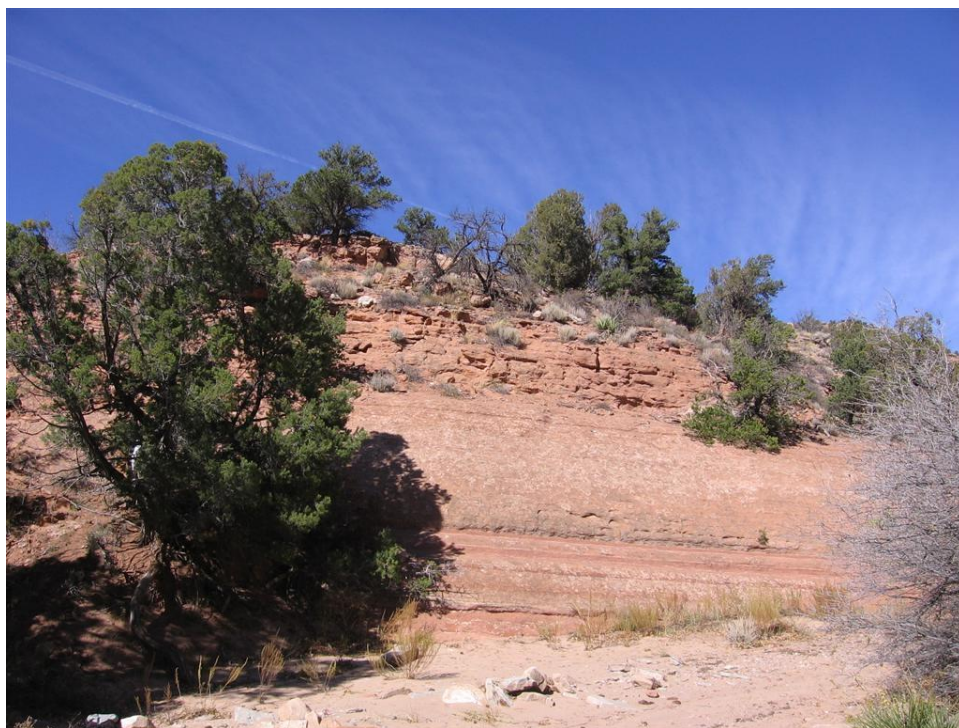
Rock debris from cliff above, two waste piles: 50' x 150'; 30' x 30'; with a total estimated volume of 1,556 yd<sup>3</sup>

Photo 5. Waste rock

2 unreclaimed waste piles
